Discharge of OXEO™ Extinguishing System in a Drop Ceiling Application

January 15, 2025

Viking Group Inc.

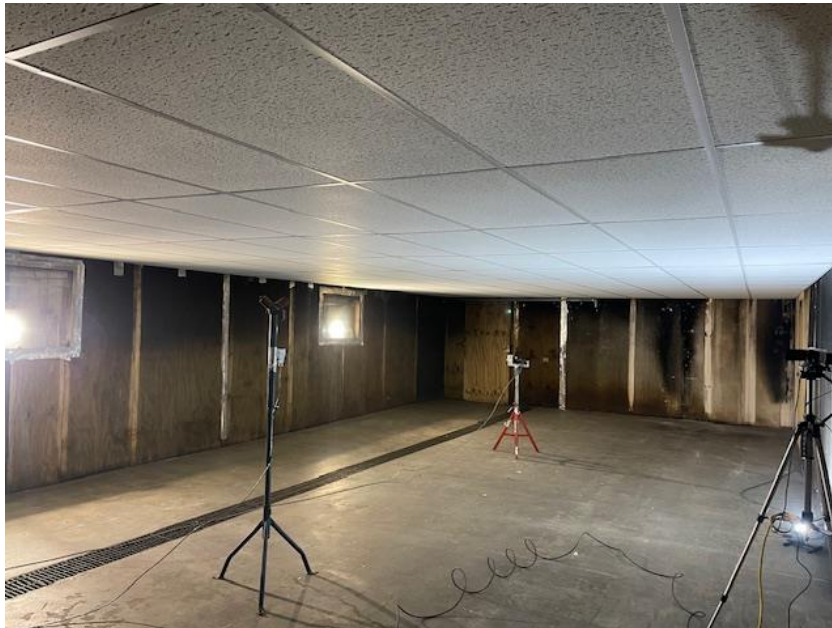
A 20' x 40' test room was constructed with a standard drop ceiling system. 2' x 4' USG Radar Basic lay-in ceiling tiles were used to construct the drop ceiling. The ceiling grid was designed and installed with hanger spacing according to the manufacturer recommendations. No ceiling tile hold down clips were used. The drop ceiling was placed 1 ft below the existing room ceiling and 6ft 9in above the floor.

Figure 1: Test Room with Drop Ceiling Installed

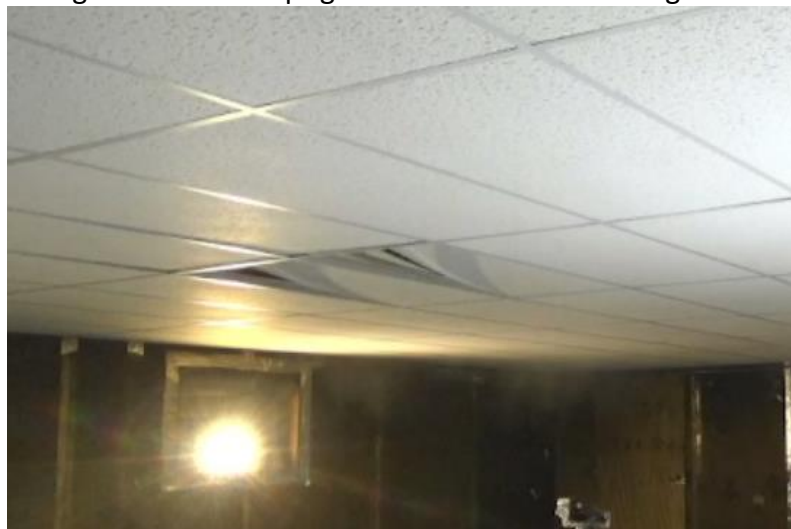
During the activation, ceiling tiles were observed being lifted slightly from the grates near the nozzle above the ceiling and near the upright nozzle below the ceiling.

Figure 5: Ceiling Tiles Being Lifted from Grates During System Discharge

Although these tiles moved during the system discharge, the tiles remain mostly intact and stayed within the ceiling brackets. Only minor permanent damage could be seen on the corners of 2 tiles nearest to the nozzle above the ceiling. No structural or tile damage was found on the rest of the ceiling.

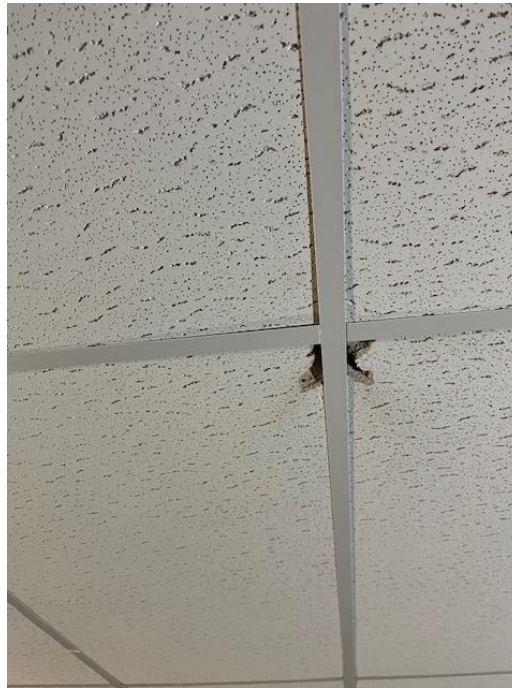
Figure 6: Permanent Damage Observed on Tiles Directly Below the Nozzle Above the Ceiling
