REPLACEMENT PARTS

DEHYDRATOR

PART NO. 01285A

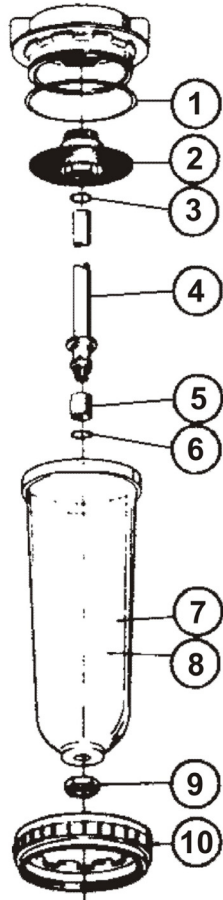
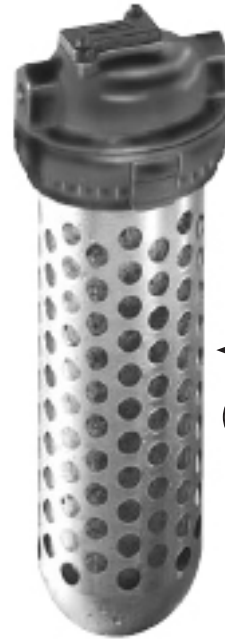
Bowl Guard Required
